Repair and Consolidation of a Large Format Broken Silver Gelatine Print on Melamine Particle Board

Chloé Lucas, Anne-Stéphanie Étienne

Presented at the 2023 PMG Winter Meeting.

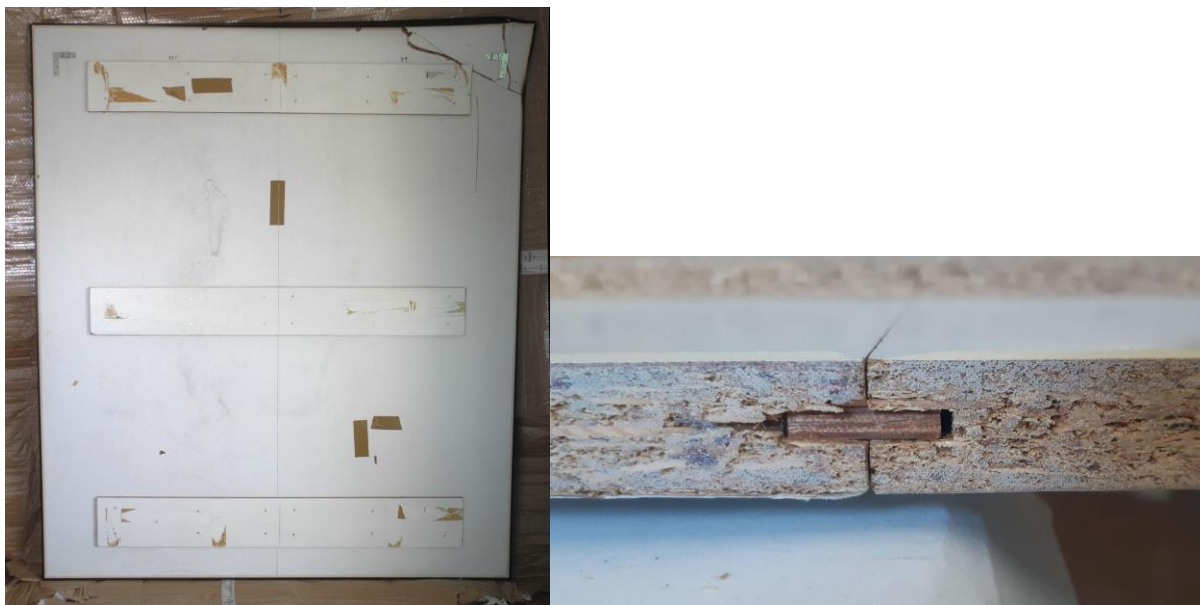
The artwork was made in 1981, is part of an edition of ten and measures 1.69 m by 1.94 m. It is composed of two semi-glossy silver gelatin prints on resin-coated paper, containing optical brightening agents. The photographs are adhered overall on two 1.9 cm thick melamine laminated wood particle boards, which are maintained together with a loose tongue and groove joint in the center. Three reinforcing pieces of the same type of board are glued and screwed into the back of the main panels (**Figure 1**). The artwork is framed in a low-profile black aluminum frame, screwed

Figure 1: Artwork's verso and loose tongue and groove joint (top edge, panel's intersection)

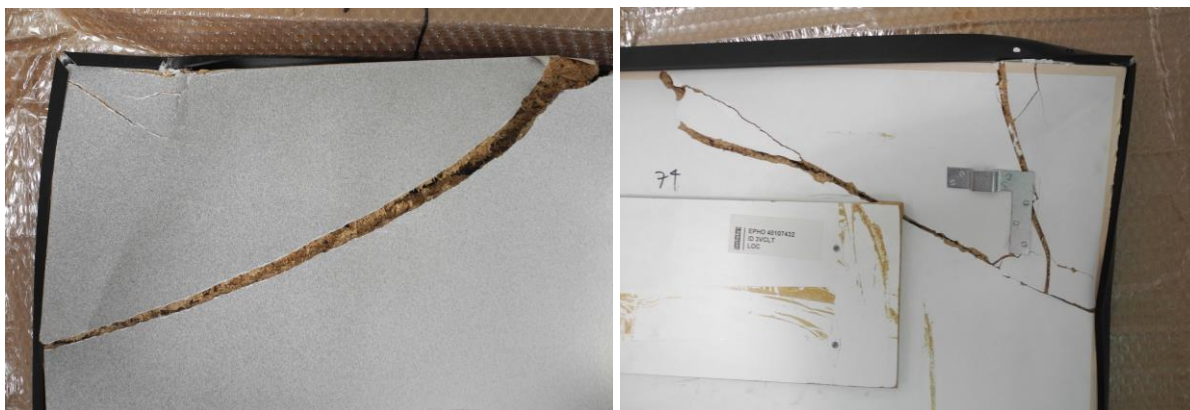
The artwork shows several physical damages. The main damage is the top left corner breakage and losses to the secondary support and subsequent tearing and losses of the silver gelatin prints on the recto, caused by the dropping of the traveling crate on its corner during handling (**Figure 2**). The corner is entirely detached from the rest of the panel and is only held in place by the frame. The framing system caused most other damages, including a large amount of dust, fingerprints, and soiling on both sides, and numerous abrasions and scratches on the photographs because of the lack of protective glazing or backing. The frame caused cracking of the secondary support where the screws are inserted, as well as losses from the top screws being ripped off the secondary support as the aluminum frame bent on impact.

Figure 2: Recto and verso of the broken top left corner before treatment.

Upon consultation with the artwork's owner, the option to repair the original corner was selected as it met the treatment goals and preserved the original artist's intent and choice of mounting material.

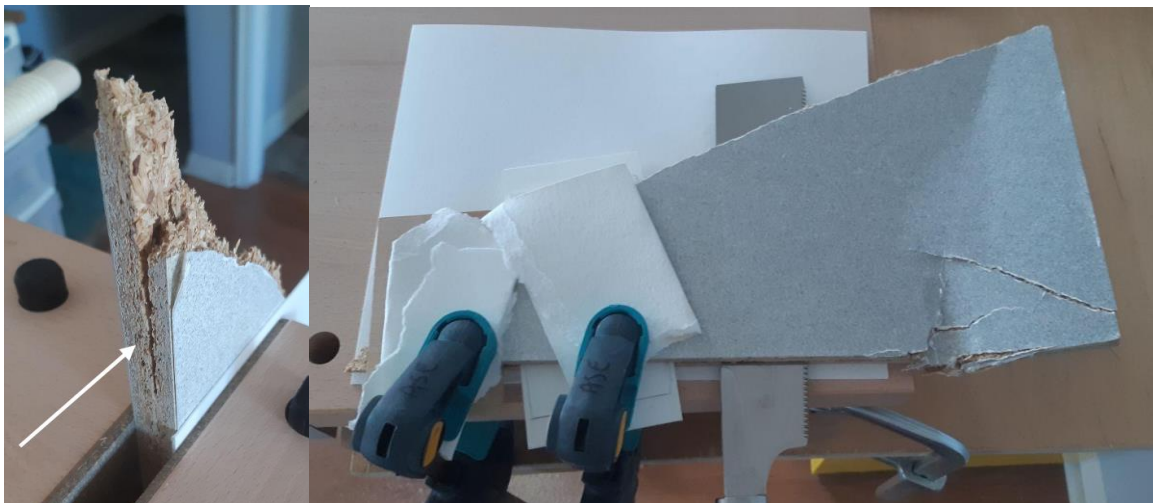
Figure 3: Corner during cutting with a Japanese plywood saw, clamped vertically for the flat area (left) or horizontally when approaching the bent area (right).

The detached corner was first split in two in the core of the panel to access the broken edges from the inside and remove some of the wood particles to enable flattening of the corner. Work was undertaken on a woodworking station, maintaining the corner in the vise or with clamps, either vertically or horizontally to accommodate the bend in the corner. Blotters were placed between the photograph and the clamps to prevent damaging the surface. The corner was cut through the middle of the wood particles with a Japanese plywood saw (**Figure 3**).

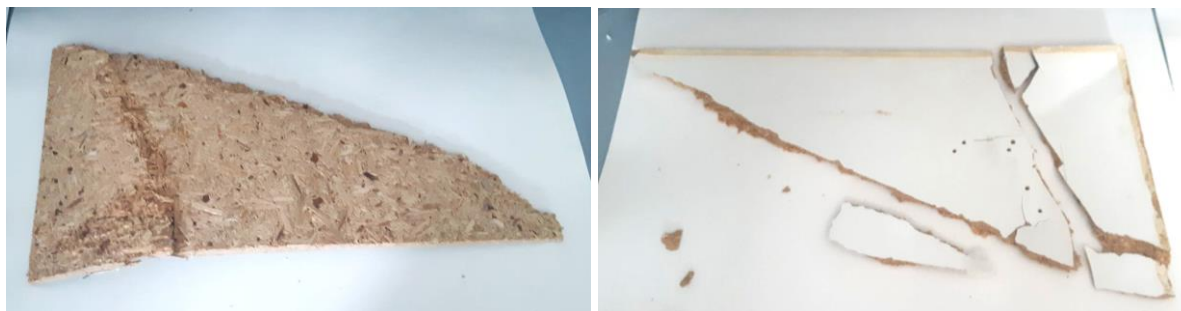
Figure 4: Inside of the front corner piece (left) and outside of the back corner piece (right)

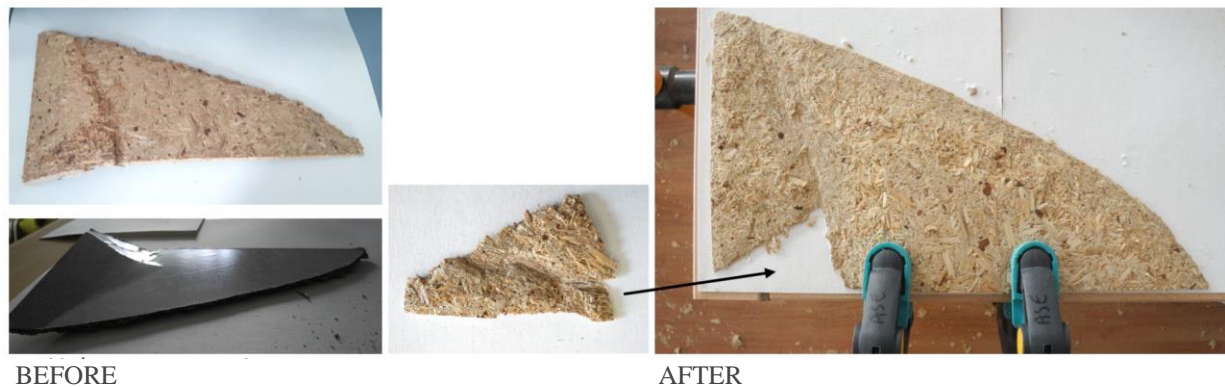
Some of the fragments were only maintained in place by the broken wood particles, which separated from each other as they were cut apart. In some areas, the wood particles had to be pared down to the melamine paper layer to realign the break edges (Figure 5).

Figure 5: Front corner piece before and after flattening

Removal of wood particles around the break was done with various tools depending on the accessibility of the break edge, the tool precision and the varying particle density. Wood scissors were used to remove larger areas of coarser particles in a flat way. A rotary Dremel tool with wood carving bits was used to remove dense wood particles closer to the break because it allowed a more controlled approach, and the tip was easier to insert between the wood particles.

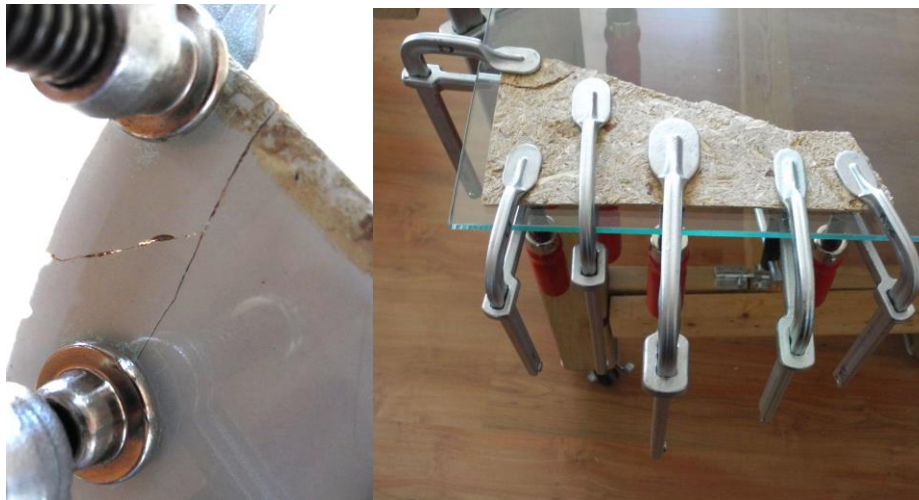
Figure 6: Outside and inside view of the back corner piece clamped on a glass plate for consolidation.

The back corner piece was repaired first. The fragments were realigned on the glass plate and clamped in place (**Figure 6**). The epoxy and a strip of 78g/m² fiberglass were applied with a brush along the break.

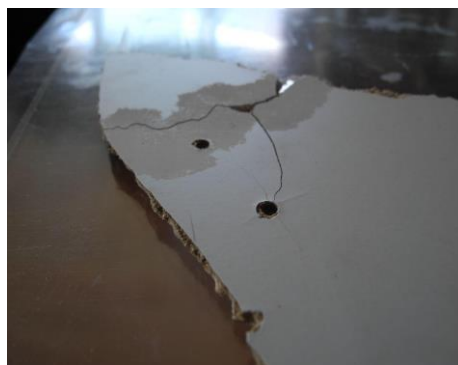
Additionally, we observed that some epoxy seeped to the outside of the back corner piece due to the small surface losses along the fracture and to the viscosity of the epoxy which was identified as too low. This resulted in a thin layer of epoxy along the break edge (**Figure 7**). This layer was removed mechanically with a scalpel without damaging the melamine surface.

Figure 7: Overflow of epoxy on the outside of the back corner piece after the first gluing.

In order to thicken the epoxy and prevent it from seeping through the cracks, wood powder filler was added until a thicker but still malleable consistency was reached (5:1:1 resin / hardener / filler). The addition of the filler succeeded in preventing the epoxy from seeping through, and the remainder of the back corner piece was repaired with this adhesive mix (**Figure 8**).

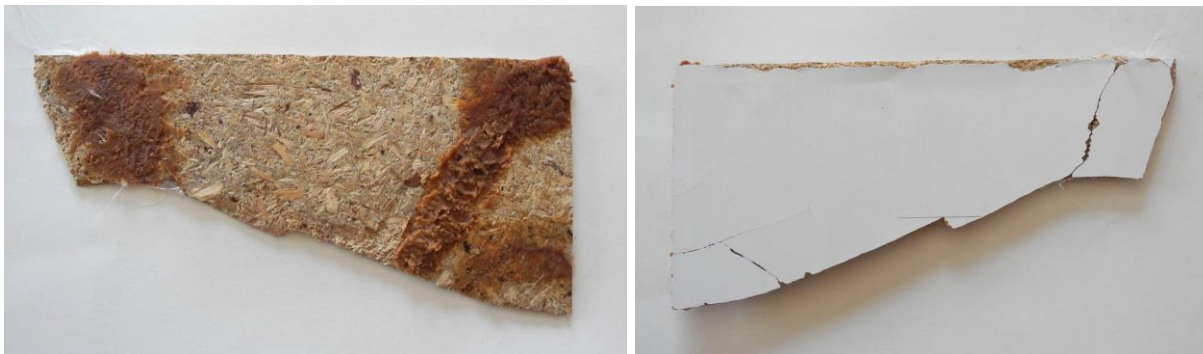
Figure 8: Back corner piece inside and outside after repair.

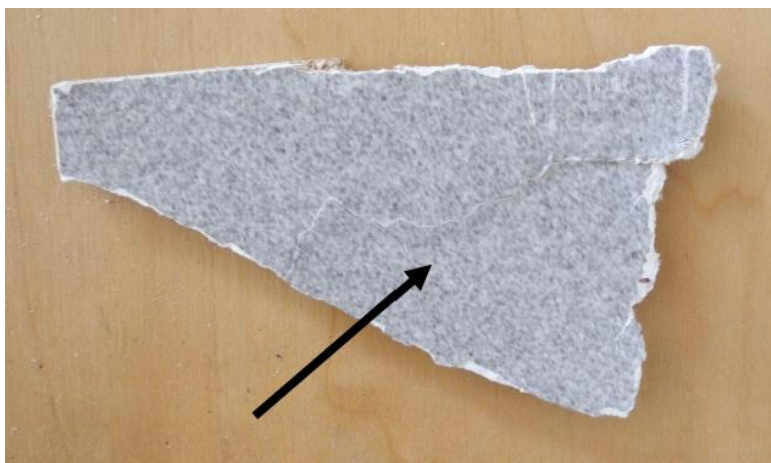
The same adhesive mix and application technique was used to repair the first break on the front piece of the corner, however, due to the fact that along this break, the wood particles had been pared down to the melaminated white paper layer to optimize the adjustment of the fracture line, the epoxy soaked through the melamine and stained the photograph (**Figure 9**). Additionally, the brown colour of the epoxy with wood powder filler was slightly visible through the melaminated paper layer. The stain was inpainted to be less visible.

Figure 9: Epoxy resin stain on the photograph (outside of front corner piece)

To avoid further staining of the photograph, additional testing was conducted to adapt the adhesive combination and application method.

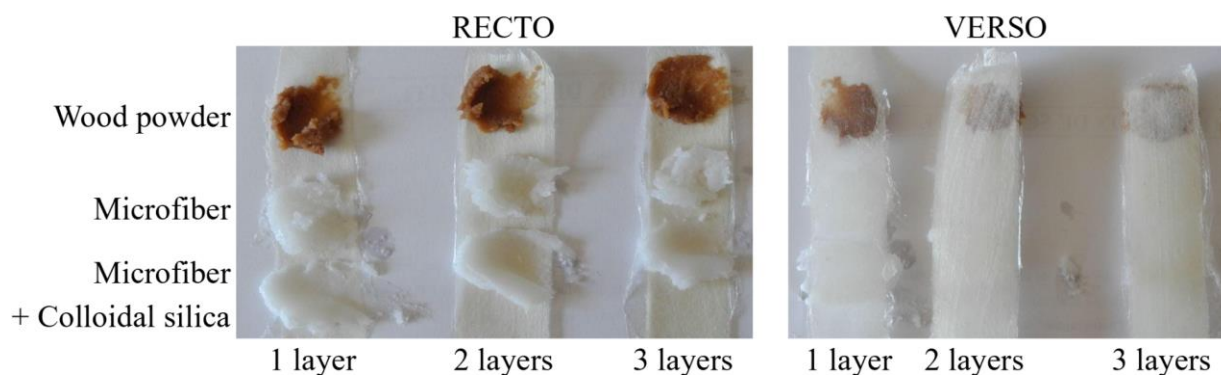
Figure 10: Isolation layer samples

The single layer option of Japanese paper / Lascaux 498 HV was eliminated because, in the case of the wood powder filler, the epoxy resin had soaked through the paper and stained the underlying paper. The double and triple layers of Japanese paper / Lascaux 498 HV were kept as a treatment option as the epoxy resin did not soak through them.

Japanese paper (25 g/m²) pasted with Lascaux 498 HV was tested as an isolation layer, used in one, two, or three layers. 3 g of each epoxy resin mix was applied to the isolation layer. Once cured, the verso of the isolation layer was examined for any visual signs of the epoxy soaking through (Figure 10).

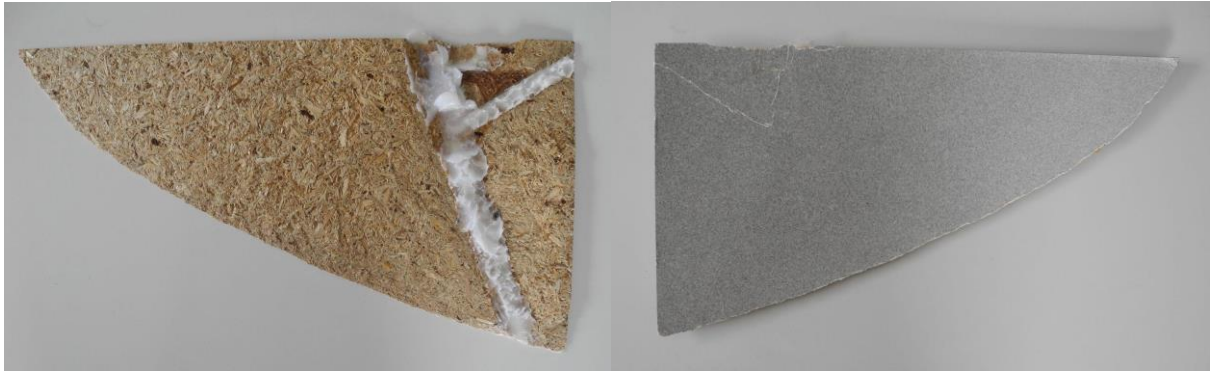
Figure 11: Front corner piece inside and outside after repair.

The remainder of the front corner piece consolidations were completed using three layers of Japanese paper / Lascaux 498 HV and the epoxy resin with the microfiber / colloidal silica combination because it was the whitest and required the least amount of filler to reach the desired consistency (**Figure 11**).

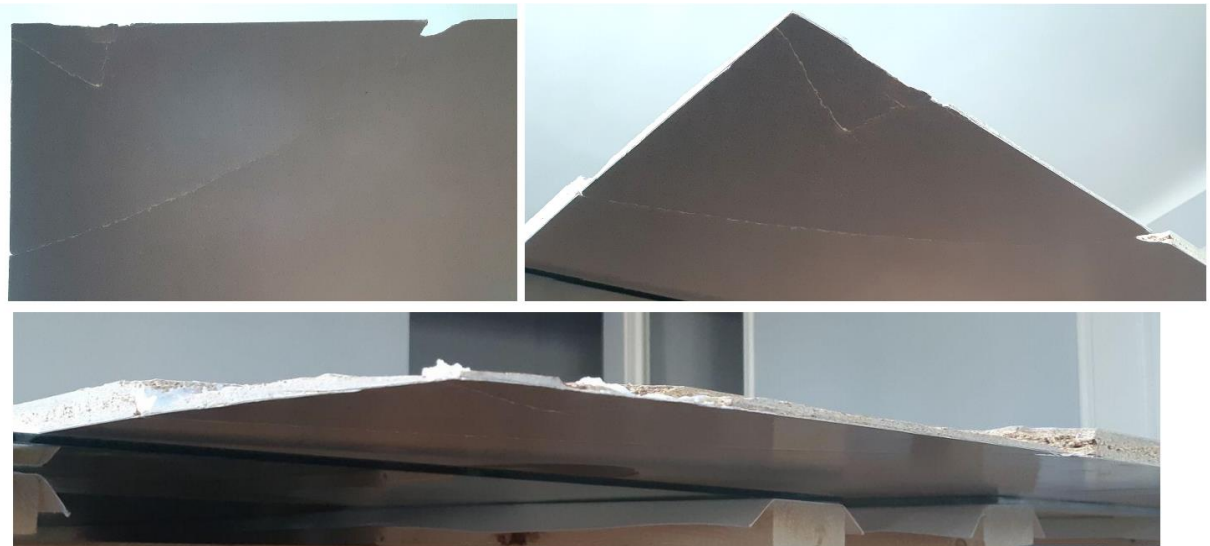
Figure 12: Front corner piece after reattachment to the main panel.

The front piece of the corner was then reattached to the main panel with the same method and material (**Figure 12**). Once the front piece was reattached to the main panel, an alternative to the fiberglass consolidant was implemented.

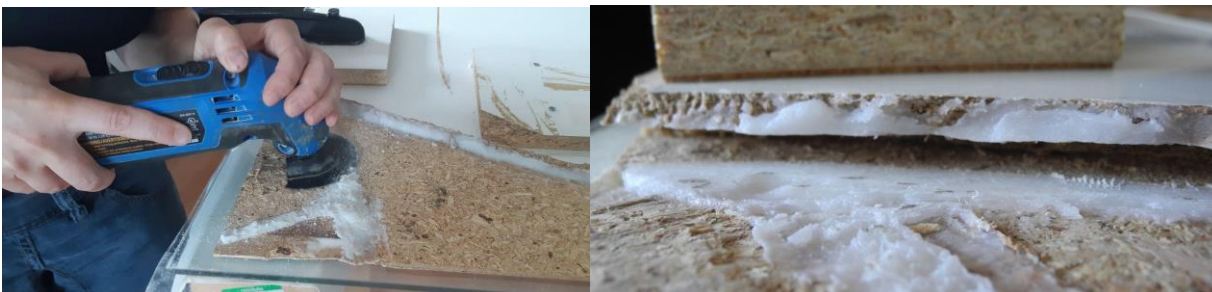
Figure 13: Front corner piece levelling and creation of a groove to insert the plywood consolidation piece.

The front and back pieces of the corner were levelled down to 0.5 cm with an oscillating power tool. The same tool was used to create a groove at the joint between the corner and the main panel, where one layer of plywood could be inserted (**Figure 13**). It was decided not to insert both plywood layers in order to avoid making the area with a wider groove more fragile than the rest of the panel.

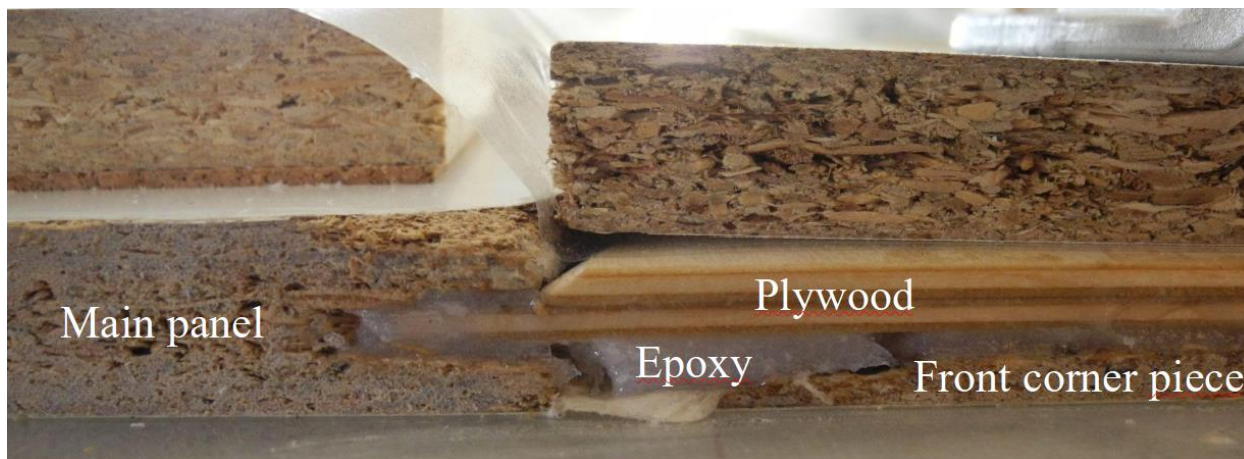
Figure 14: Cross-section view of the front corner piece and two plywood reinforcement pieces during curing.

To adhere the first layer of plywood, we used the microfiber / colloidal silica-filled epoxy applied as a 0.5 cm layer on the whole inner surface of the front corner piece. The first plywood piece was then inserted inside the groove and clamped in place to cure. Clamping pressure was increased progressively, and the epoxy overflow was removed from the edges to prevent it from potentially going on to the recto of the artwork. The second layer of plywood was adhered to the first with a thin layer of clear epoxy (**Figure 14**).

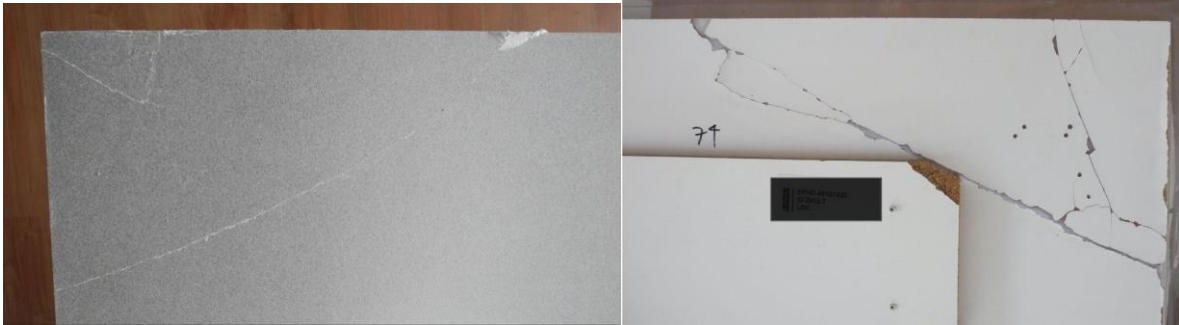
Figure 15: Recto and verso of corner after consolidation and repair

The back corner piece was then adhered to the second layer of plywood with the same method described above for the front corner piece and first plywood layer adhesion (**Figure 15**).

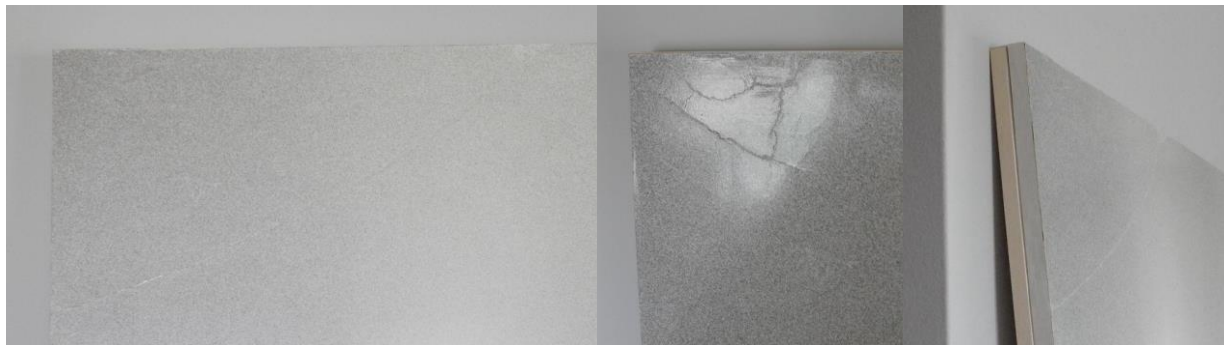
After treatment, the corner breakage is still visible in raking light, and under close examination, because of the differential gloss between the semi-glossy photographs and the matte losses; however, when the artwork is viewed from the front as a whole, the corner damage blends in (**Figure 16**).

Figure 16: Recto of the corner after treatment.
